# A masterclass in castables

**Herbert Hoel, REFKO, outlines the benefits of a new castable magnesia spinel solution which promises new opportunities for rotary kiln lining repair.**

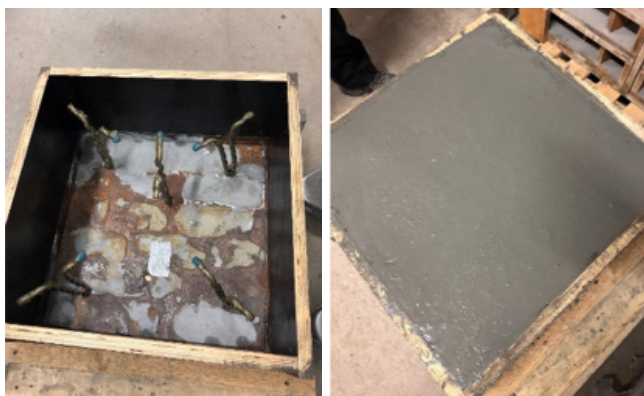
**Figure 2. A block of the castable solution was cast and then used as the door of the test furnace.**

A disadvantage of castable solutions is that sometimes they have to follow a special heating-up pattern. Therefore, the goal was to design a castable that can be heated up with the standard heat-up procedure of a rotary kiln. Accordingly, another REFKO in-house test procedure was developed.

A block, including anchors, with dimensions of 500 mm x 500 mm and a thickness of 250 mm was cast (Figure 2). This block was then used as the door of the test furnace. The furnace was then heated up following a procedure obtained from a cement kiln operator. Once cooled, the block was

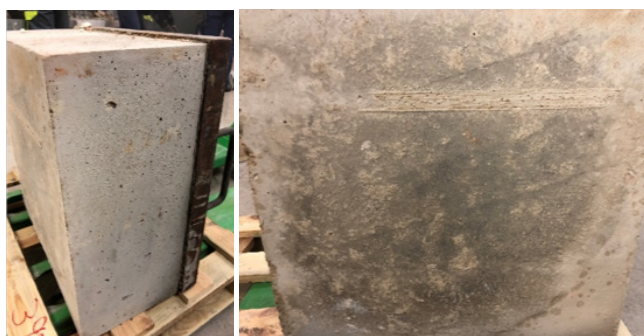
**Figure 3. No cracks could be found in the cast block after the kiln heating up procedure.**

inspected for cracks. In this instance, no cracks were found after the test (Figure 3).

Evidently, the rotary kiln can be heated up under the same heating-up schema that is valid for the normal start of a kiln after refractory repair.
