In the **Line of Fire** >>>>

*Herbert Hönl, Refko Feuerfest, Germany,
Belen Caballero and Eduardo Diez del Sel,
Reyma Materiales Refractorios, Spain, discuss
monolithic material and lining solutions for
cement plants with a high mechanical and
chemical stress caused by increasing amounts of
secondary and/or alternative fuels.*

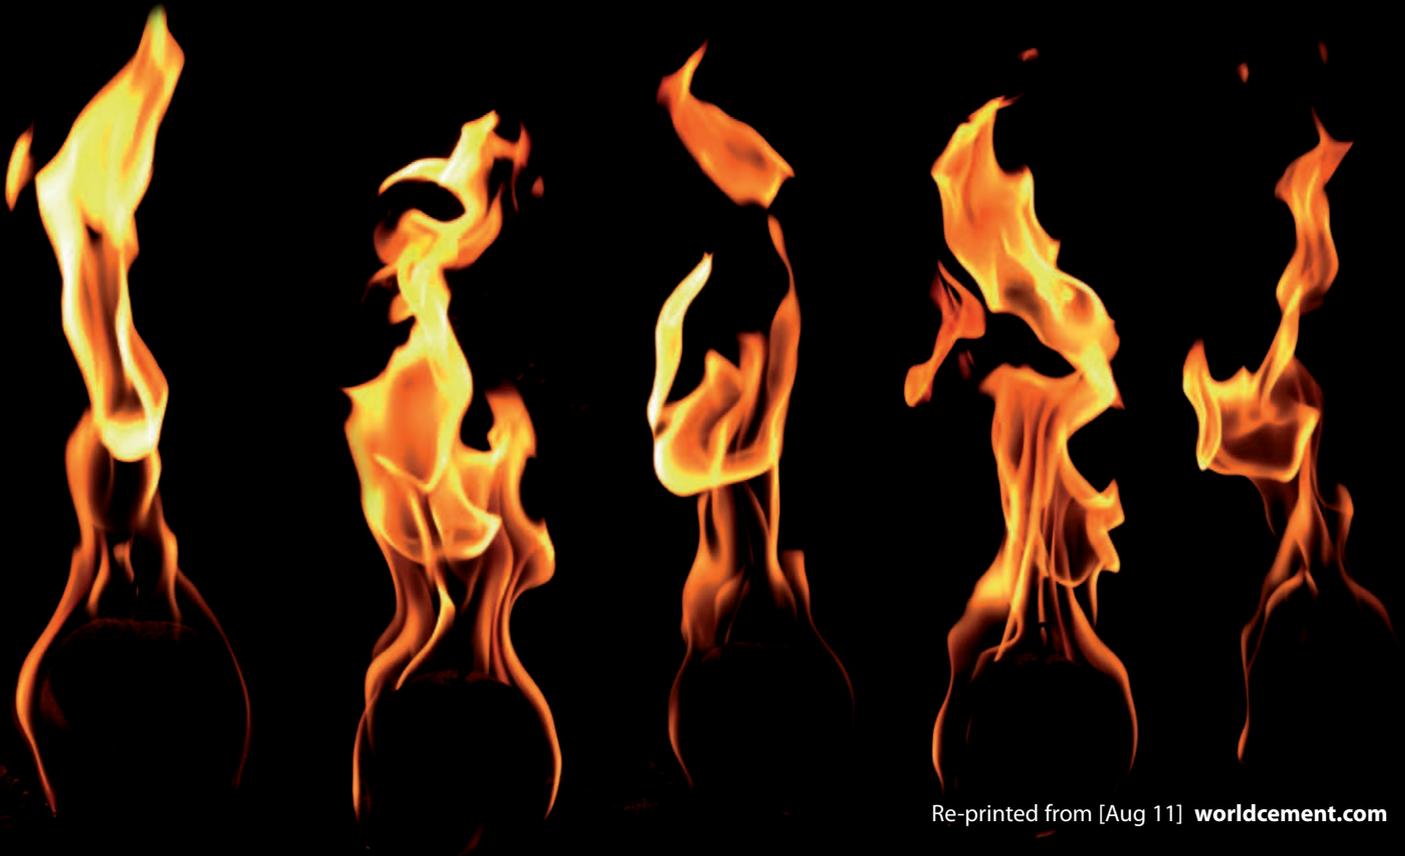
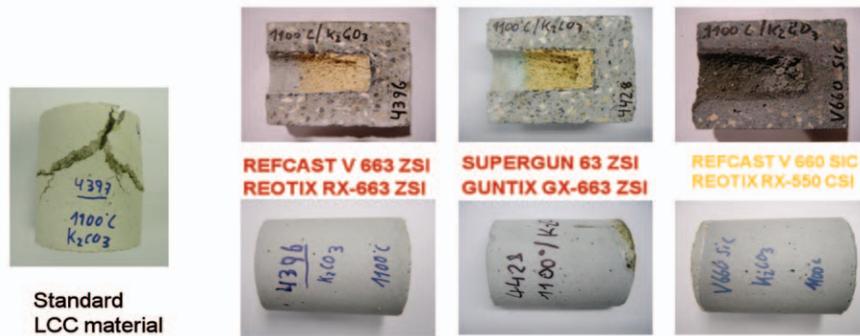
Figure 1. Alkali bursting test (5 h at 1100 °C with K₂CO₃)

The alkali bursting of an unprotected standard product is clearly visible in Figure 1. The classic materials with 60% SiC (660 SIC) show an infiltration, but no alkali bursting. Only the ZSI products show no infiltration.

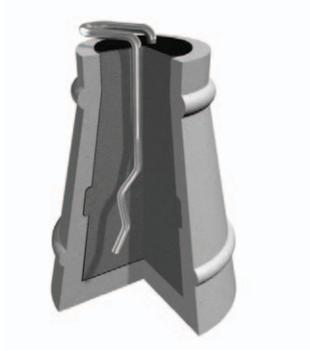
Figure 2. Refko Seal Anchor System.

For very hard corrosive conditions, as an additional solution, the Refko Seal Anchor System was developed (Figure 2). The metallic anchor is protected in an inner ceramic ZSI core with special coating and heat treatment. This is then stored in an almost gas-tight ceramic ZSI body, allowing no corrosive gases to reach the metallic anchor. There is no condensation and corrosion to the metallic anchor, as an additional layer of castable protects the inner core.
